EFFECTS OF STRAY CAPACITANCE ON HIGH VOLTAGE TESTING OF VEHICLE-MOUNTED ELEVATING AND ROTATING AERIAL DEVICES IN ACCORDANCE WITH ANSI/SIA A92.2-2009

Hipotronics Engineering Staff
Hipotronics Inc. 1650 Route 22 North
Brewster, NY 10509 USA

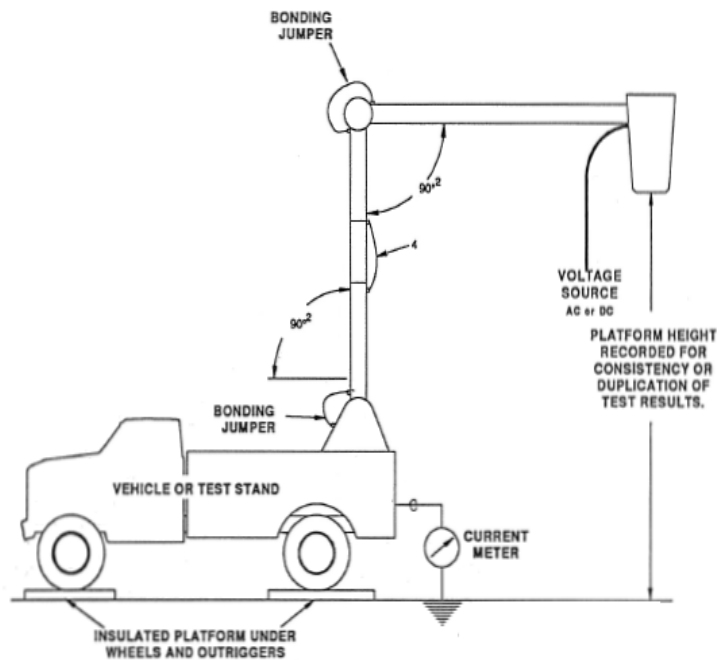
Figure 1. Dielectric Test Configuration for Category C Aerial Devices [1]

Bonding jumpers are connected across the elbow, across the lower arm (#4 on the above drawing) and from the boom to the truck. High Voltage is then applied to the boom directly behind the bucket connection. Current measurement is taken from the return, located on the rear bumper. In addition to the insulation of the tires, the truck is also on insulated platforms both under the wheels and outriggers.

The tests conducted on the boom trucks are held to ANSI/SIA Standard A92.2-2009, which sets forth all testing aspects for Vehicle-Mounted Elevating and Rotating Aerial Devices. The test setup used is outlined in the standard and is illustrated below in Figure 1.

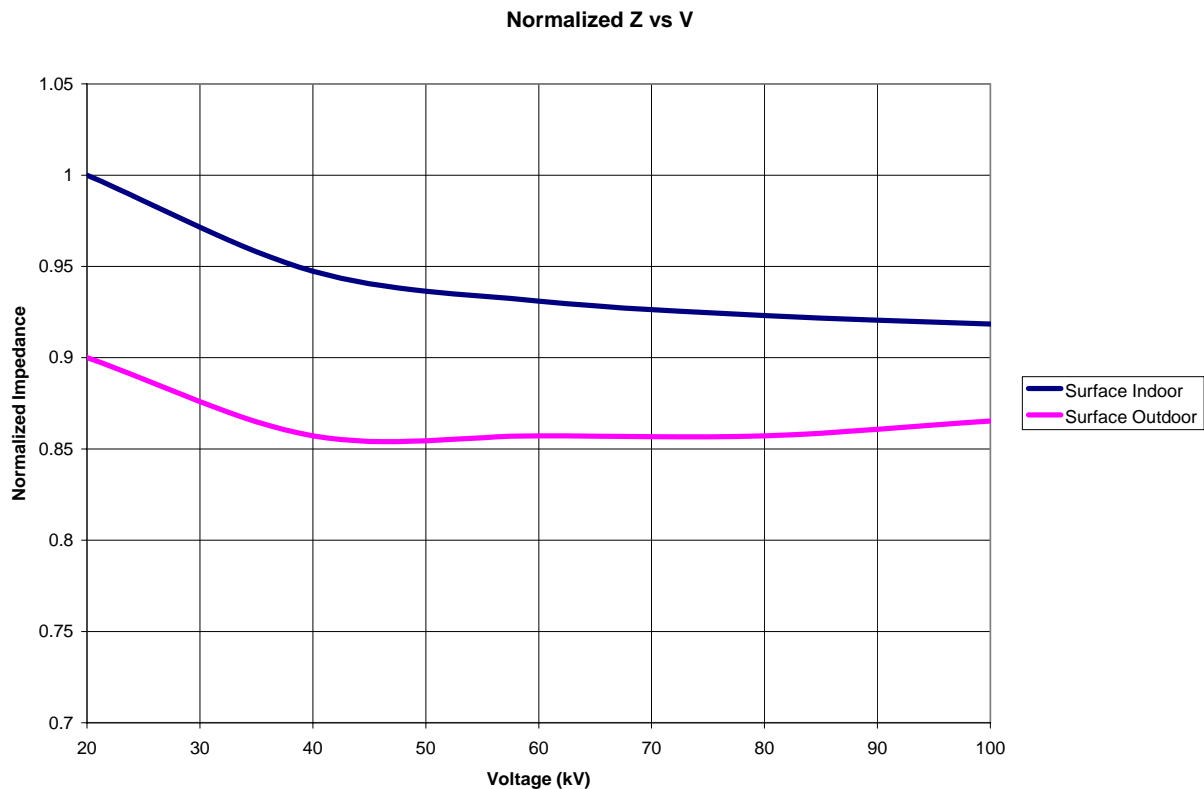
Figure 3. Plotted trends of Normalized Impedance vs. Applied Test Voltage

Extensive testing was performed on various types of cylindrical electrical insulators. Intentions were to simulate the test object, setup, and environment in order to obtain the most comparable results. Data points were taken from 20KV – 100KV, in 20KV steps, thus providing a substantial pool of data for analysis. Figure 3, below, shows a plot of normalized “lumped impedance” versus applied test voltage taken in both indoor and outdoor environments. This data was extrapolated from measurements of leakage currents measured at the return of the AC source. The trend of the lines individually is not particularly as important as the displacement between them. The findings prove that performing test procedures in an indoor environment give rise to error in leakage current readings as a result of increased capacitive coupling. In this case, the effects of stray capacitance cause the coupling of charge to points elsewhere in the environment, thus reducing the real component of the return current to the AC source. Viewing the graph, a 7.5% average decrease in impedance is measured when testing outdoors versus indoors.

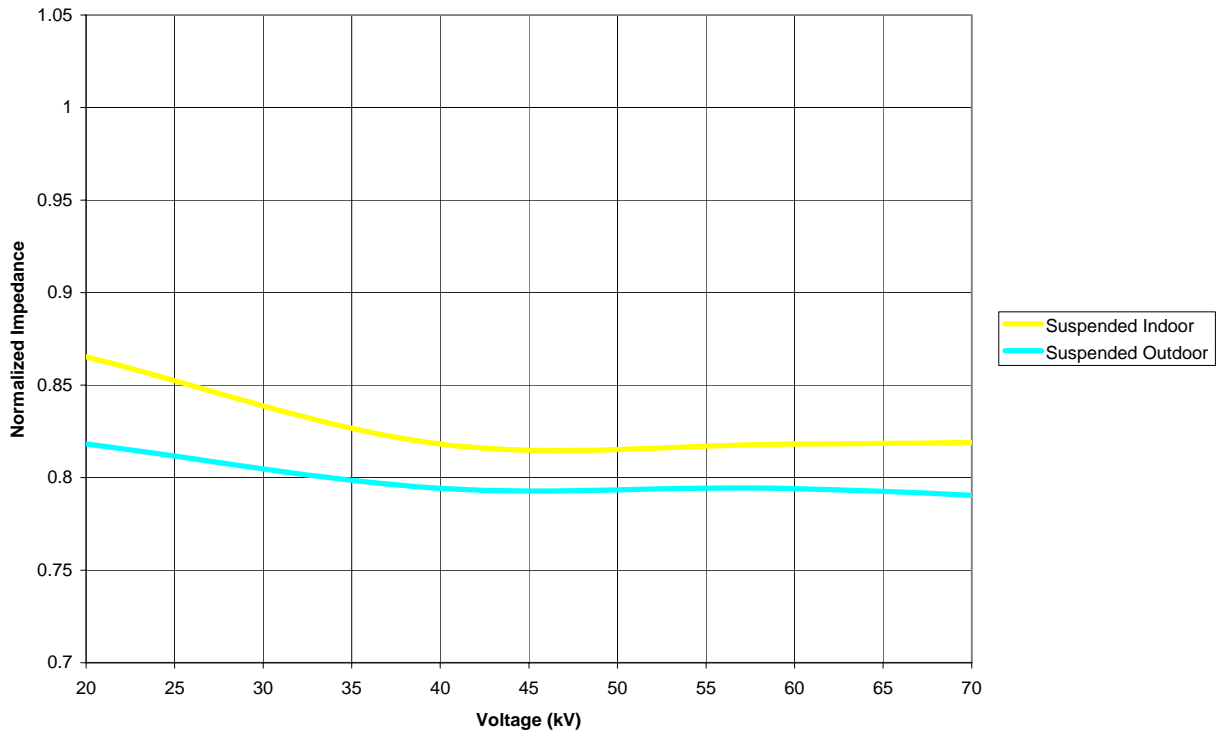
Figure 4. Effects of rerouting metering cables on impedance measurements

A second set of data showed that there can be cabling discrepancies. Data collected shows that the leakage current level measured by the AC supply is dependent upon the location of the high voltage supply return cable. Several orientations of cable routing were attempted in order to reduce effects of stray capacitance, the most effect of which was the suspension of the return wire from the grounded steel-reinforced-concrete flooring in the indoor environment. Measurements taken conclude that suspending the return cable, in air, reduces capacitive coupling of the return signal to the ground plane. This allows for a more accurate reading at the current meter of the AC source. Figure 4 displays plots of the experimental data. Two qualities of these line plots are of interest; the overall impedance measurements are reduce by approximately 10% and the average displacement between the indoor and outdoor readings is reduced by approximately 40%.

It was observed that, with orientations favoring a reduced value of stray capacitance, the testing would produce higher leakage current readings at the AC source.
